INVENTORY OF MONUMENTS AT PAGAN

Volume One
Monuments 1-255

PIERRE PICHARD

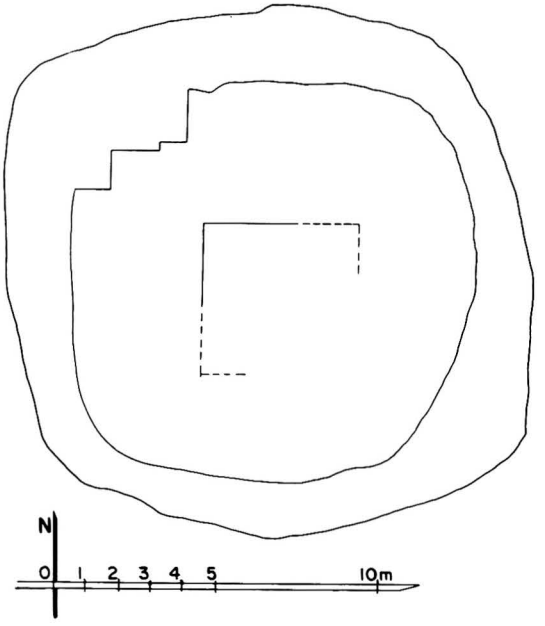
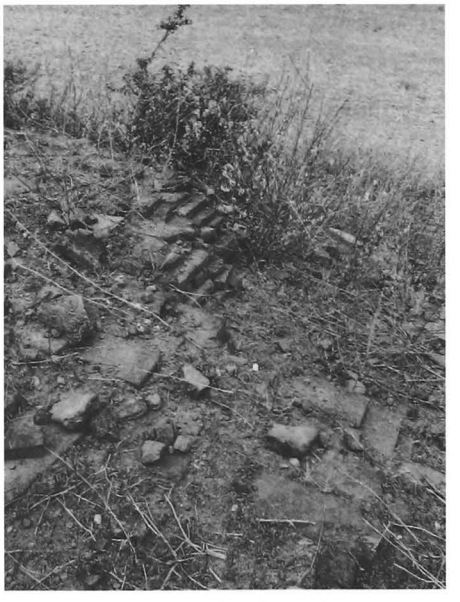
613 a - Plan

5 present condition
- brick and stone debris.
- traces of a square structure.
- height: approx. 2.60 m.

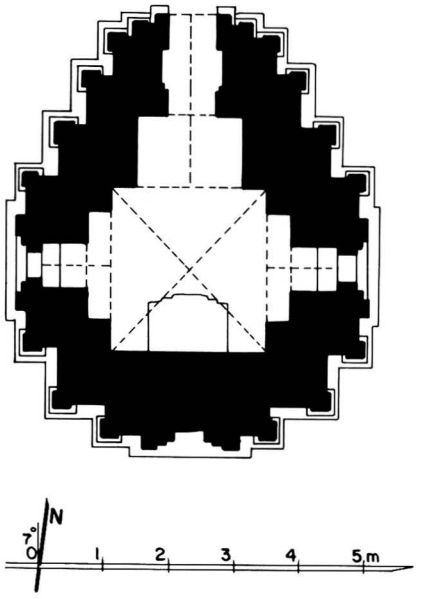
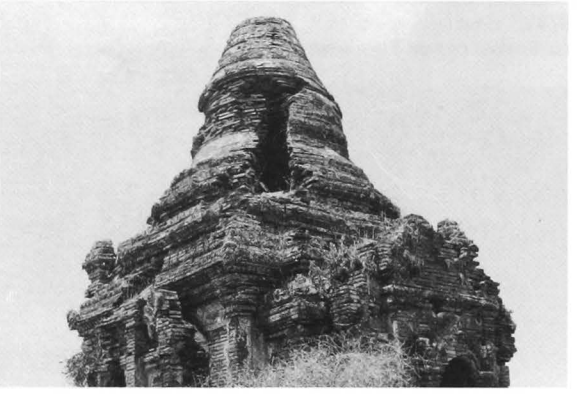
614 a - Plan

5 present condition
- no maintenance.
- upper parts badly damaged.

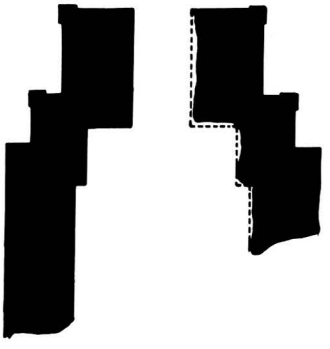
615 a - Plan

5 present condition
- ruined.
- south wall, vaults and upper parts collapsed.

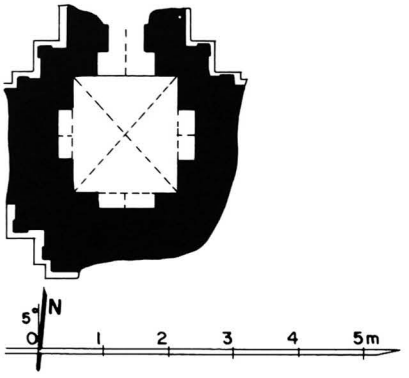
616 a - Plan

5 present condition
- ruined.
- vaults and upper parts collapsed.
- ground floor buried under debris.

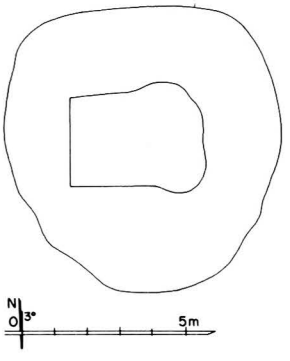
618 a - Plan

5 present condition
- brick debris.
- height: approx. 1.00 m.

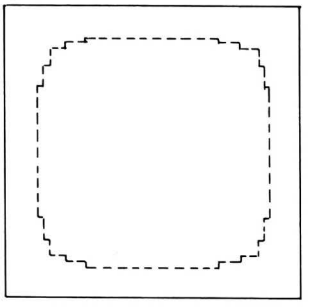
621 a - Plan

5 present condition
- ruined.

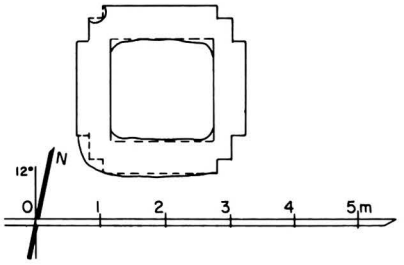
622 a - Plan

5 present condition
- ruined.

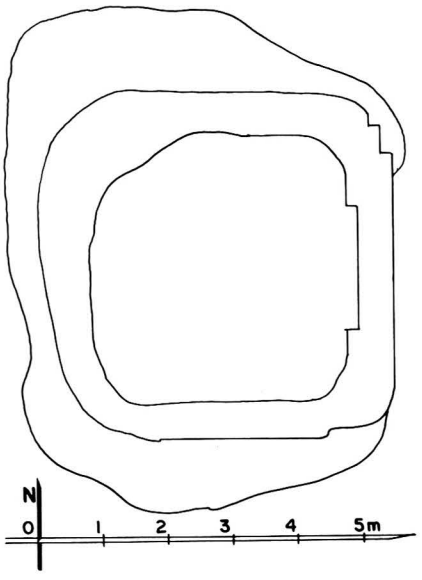
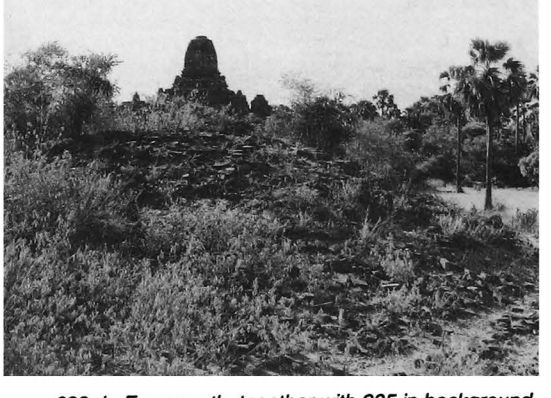
623 a - Plan

5 present condition
- brick debris.
- height: approx. 1.20 m.

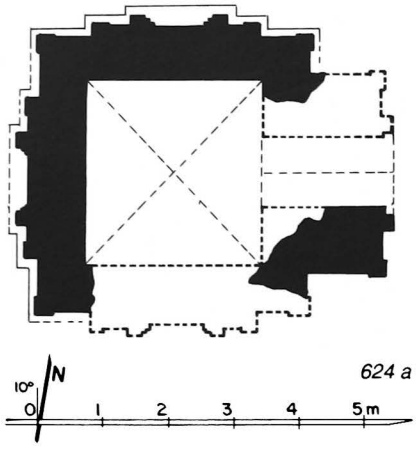
624 a - Plan

5 present condition
- ruined.
- vaults and upper parts collapsed.
- ground floor buried under debris.

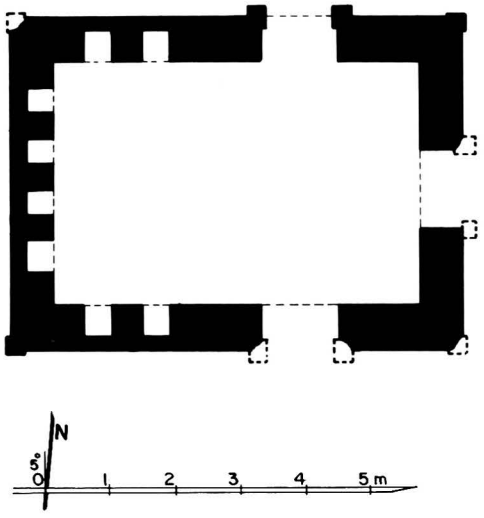
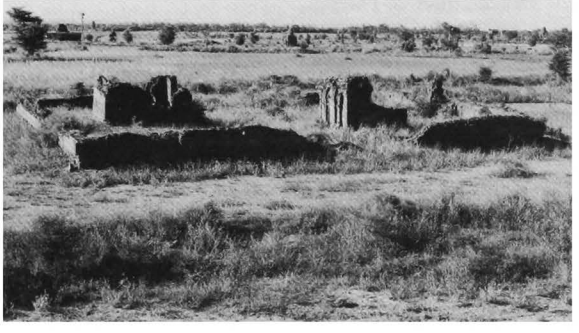
625 a - Plan

5 present condition
- ruined.
- no more trace of vaults.

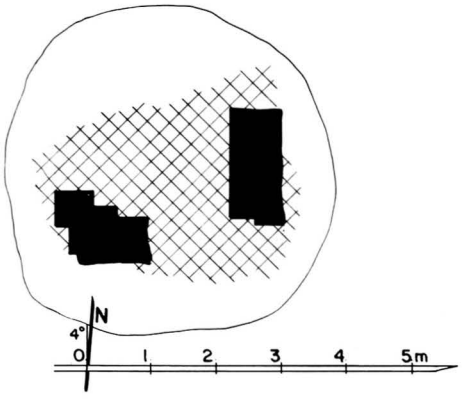
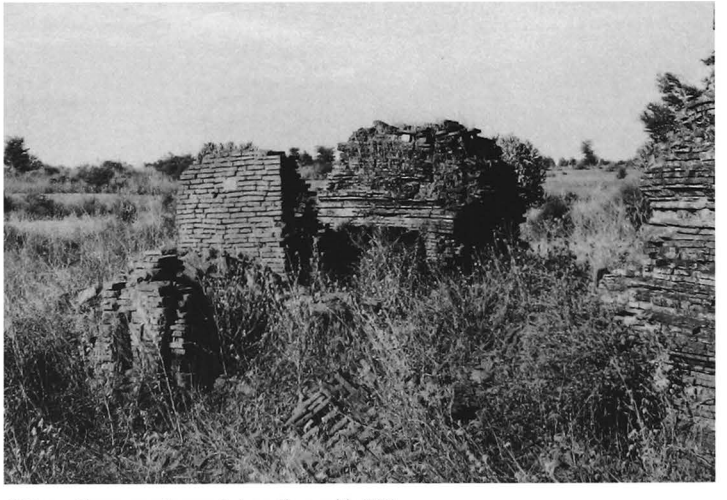
626 a - Plan

5 present condition
- ruined.
- no more trace of vaults.
- ground floor buried under debris.

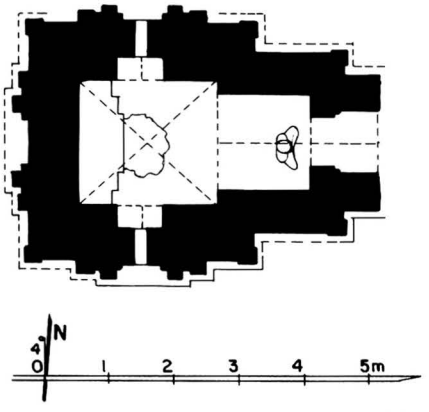
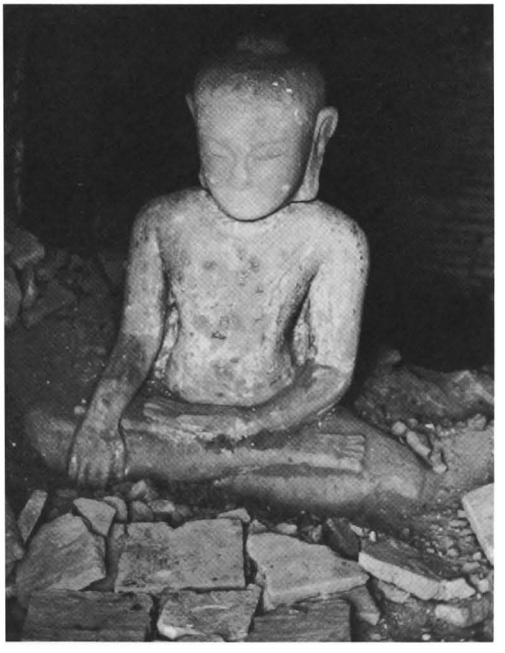
627 a - Plan

5 present condition
- half-ruined.
- upper parts badly damaged.

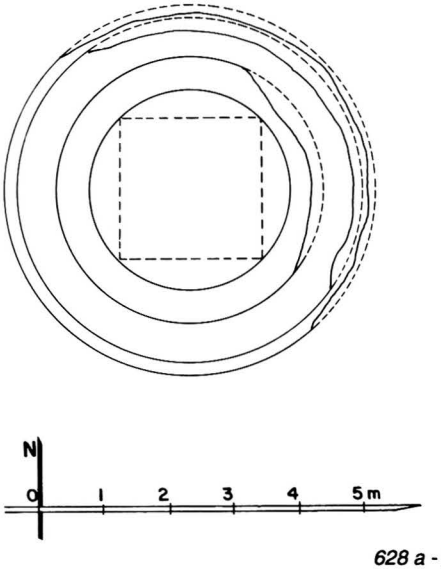
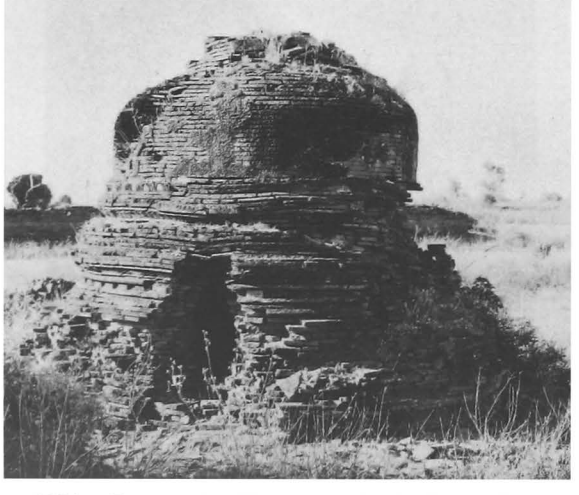
628 a - Plan

5 present condition
- no maintenance.
- terraces disintegrated.
- upper parts damaged.

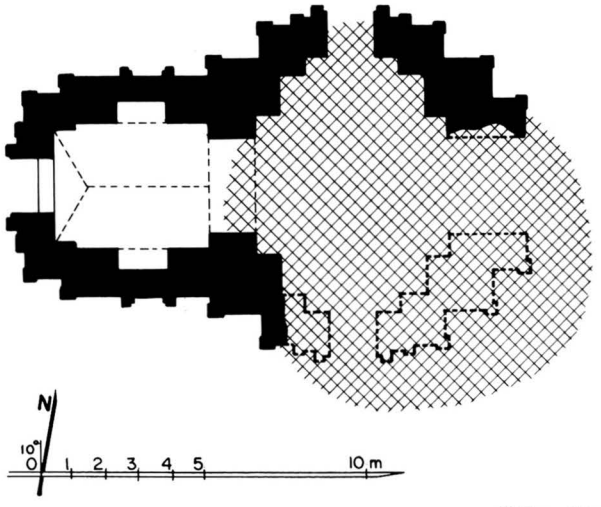
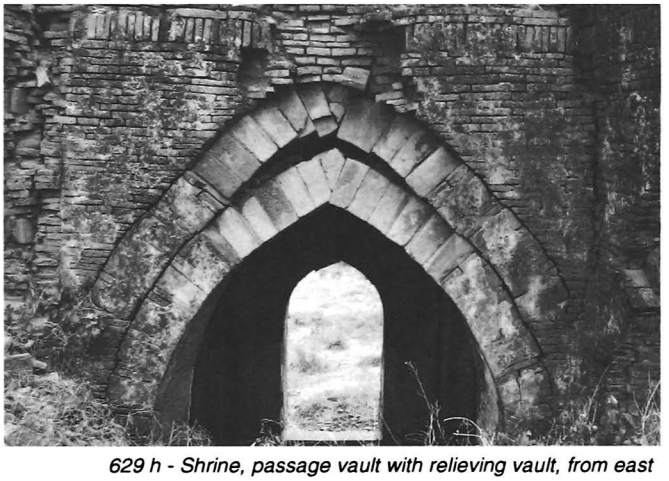
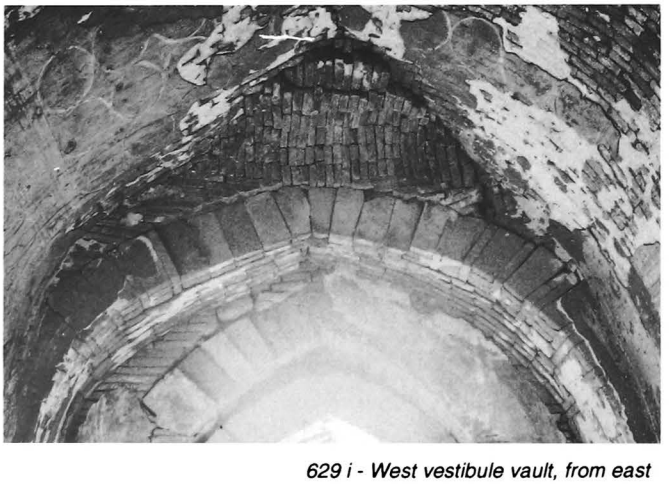
629 a - Plan

5 present condition
- ruined.
- south-east quarter collapsed.
- vault over shrine and upper parts collapsed.
- ground floor partly buried under debris.

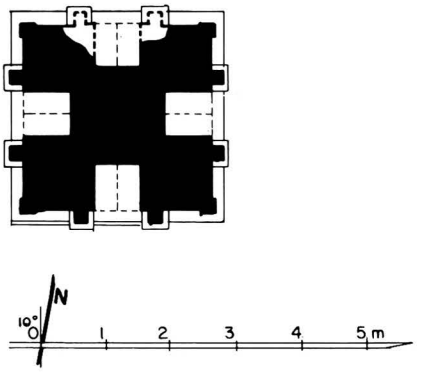
630 a - Plan

5 present condition
- no maintenance.
- upper parts collapsed.

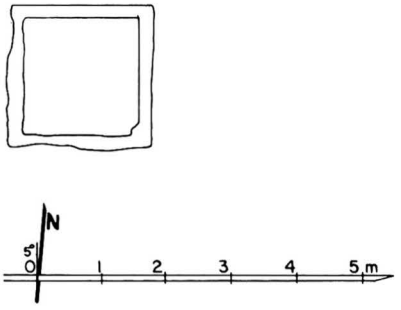
631 a - Plan

5 present condition
- half-ruined.
- upper parts collapsed.

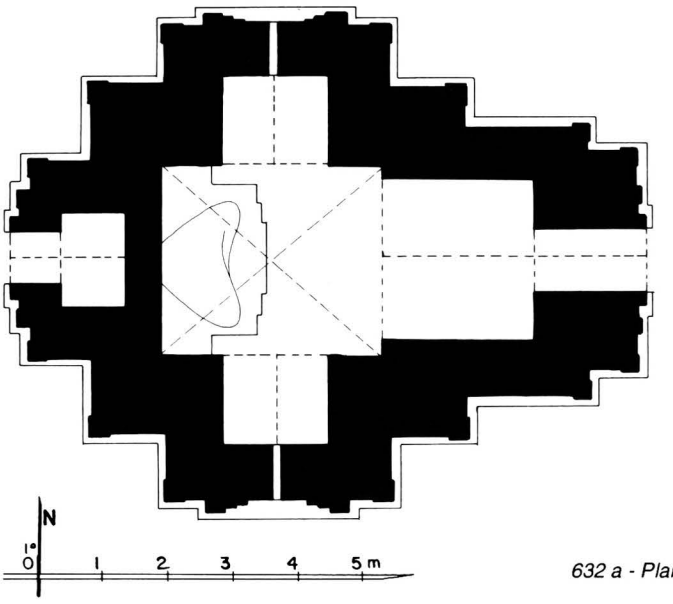
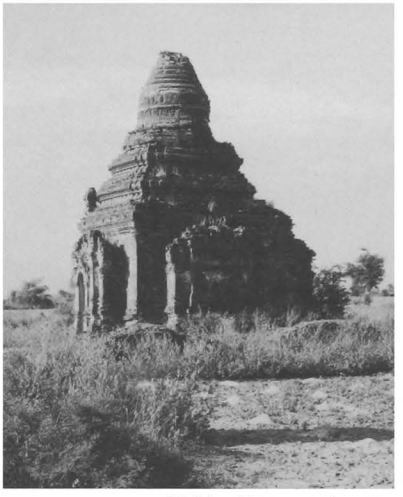
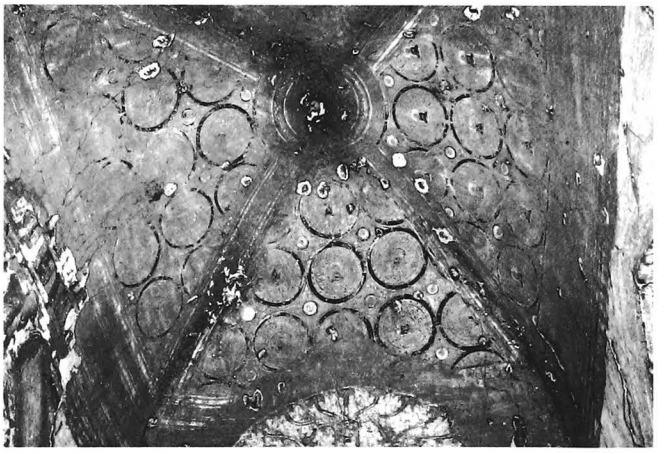
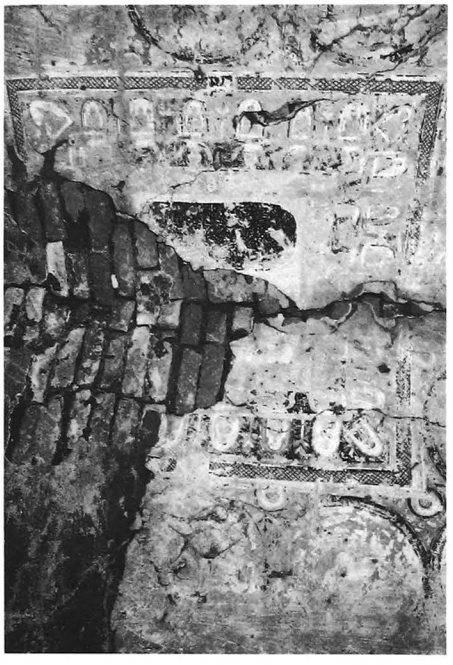
632 a - Plan

5 present condition
- no maintenance.
- upper parts damaged.

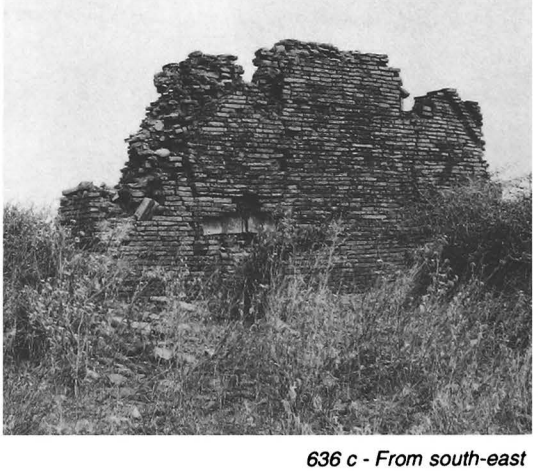
5 present condition
- ruined.
- no more trace of vaults.
- west part destroyed by erosion of stream bank.
- ground floor buried under debris.

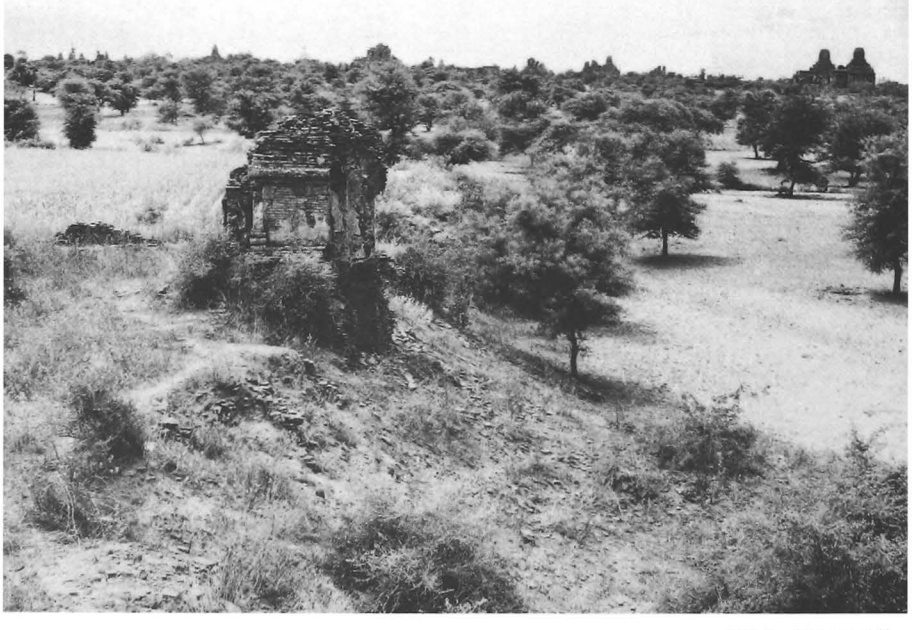
642 b - From north

5 present condition
- ruined.
- shrine and upper parts destroyed by erosion of stream bank.

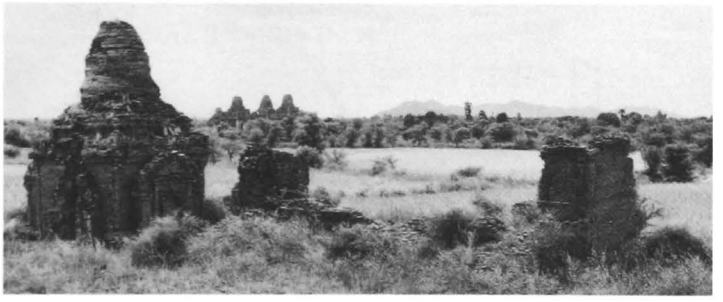
643 c - From south-east, together with 644

5 present condition
- no maintenance.
- half-ruined.
- porches collapsed.
- upper parts badly damaged.

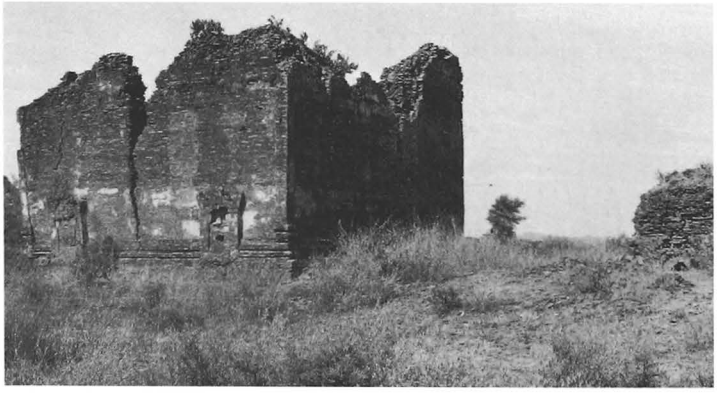
648 b - North face

5 present condition
- ruined.
- vaults collapsed.
- structure badly cracked.

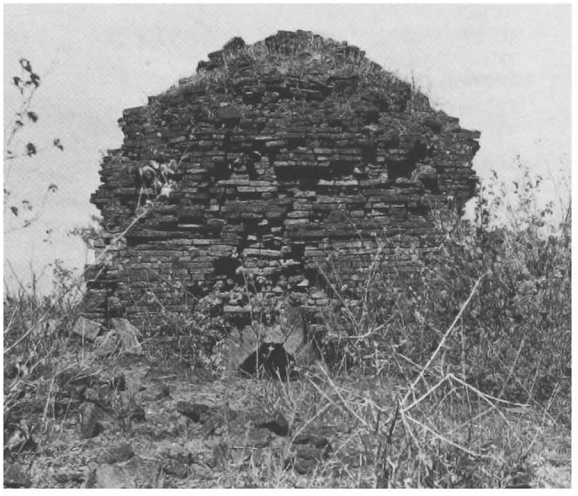
649 b - East face

5 present condition
- no maintenance.
- half-ruined.
- upper parts collapsed.

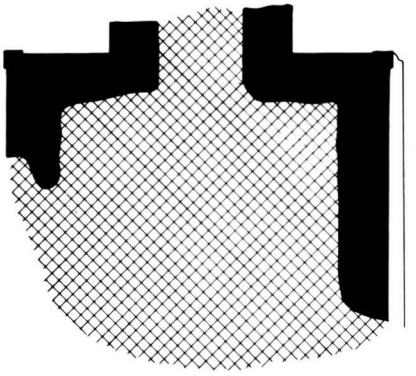
4 construction
- brick masonry.
- barrel vault hipped at outer end over shrines.
- barrel vault over porches and corridor.

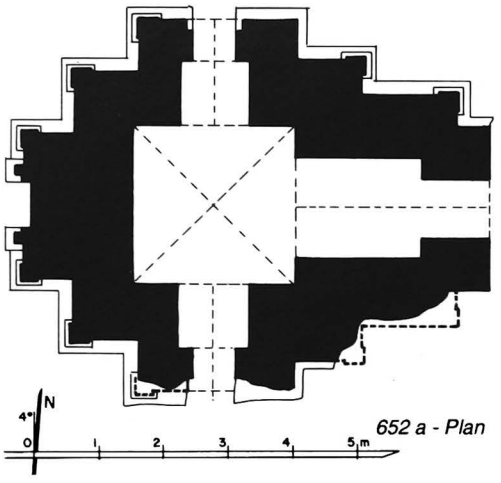
652 a - Plan

5 present condition
- half-ruined.
- base disintegrated, repaired 1993.
- porches collapsed.
- upper parts badly damaged.

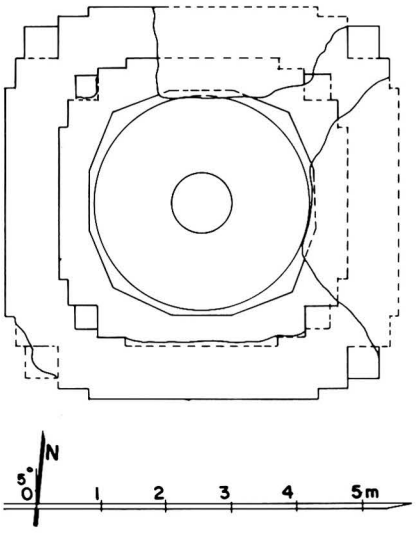
654 a - Plan

5 present condition
- no maintenance.
- half-ruined.
- upper parts badly damaged.

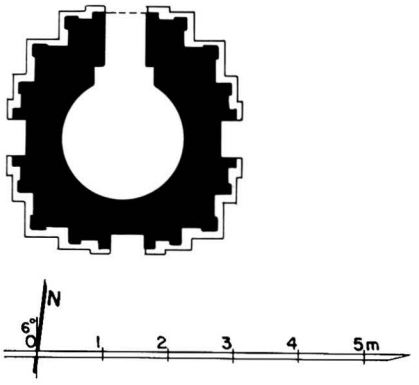
655 a- Plan

5 present condition
- ruined.
- vaults collapsed and upper parts collapsed.

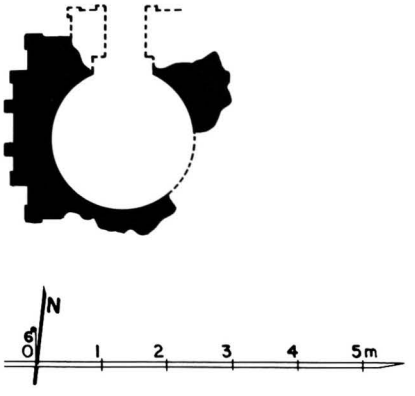
656 a - Plan

5 present condition
- ruined.
- vaults collapsed and upper parts collapsed.
- walls partly collapsed.

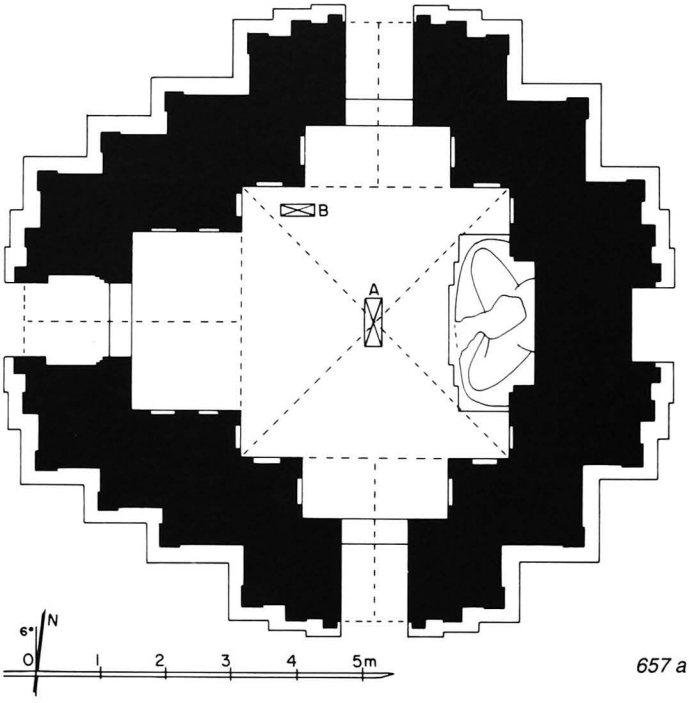
657 a - Plan

5 present condition
- regularly maintained.
- dome leaning southwards.
- brick grilles built by Arch. Dept.

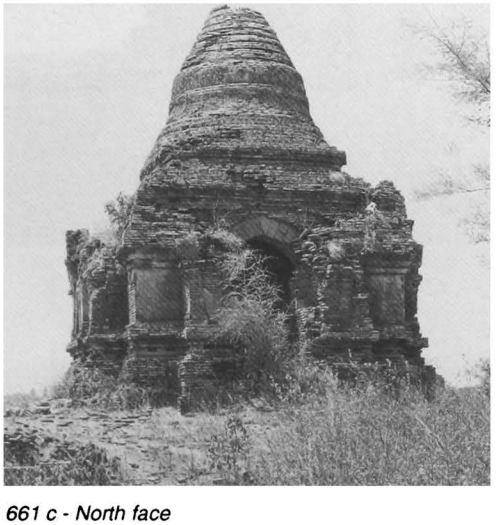
5 present condition
- no maintenance.
- east porch collapsed.
- no more trace of vaults.

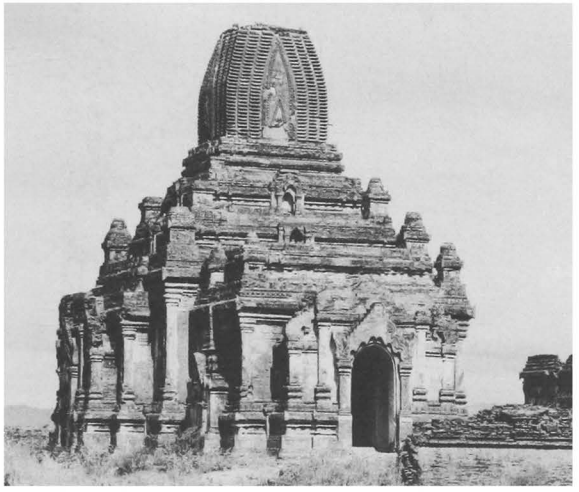
664 b - East face, from south-east

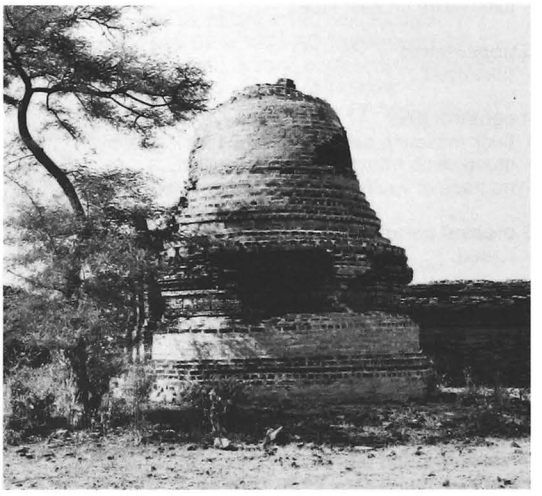
666 d - From south, 1993, after repairs

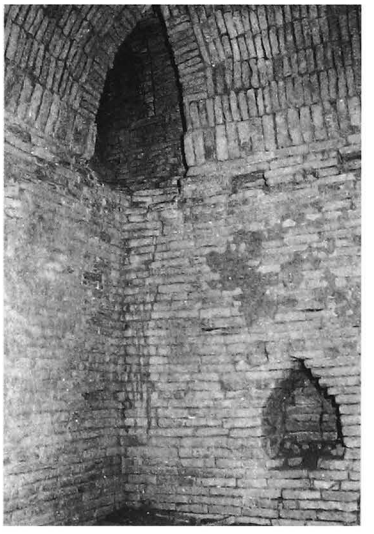
668 e - North room, south-west corner

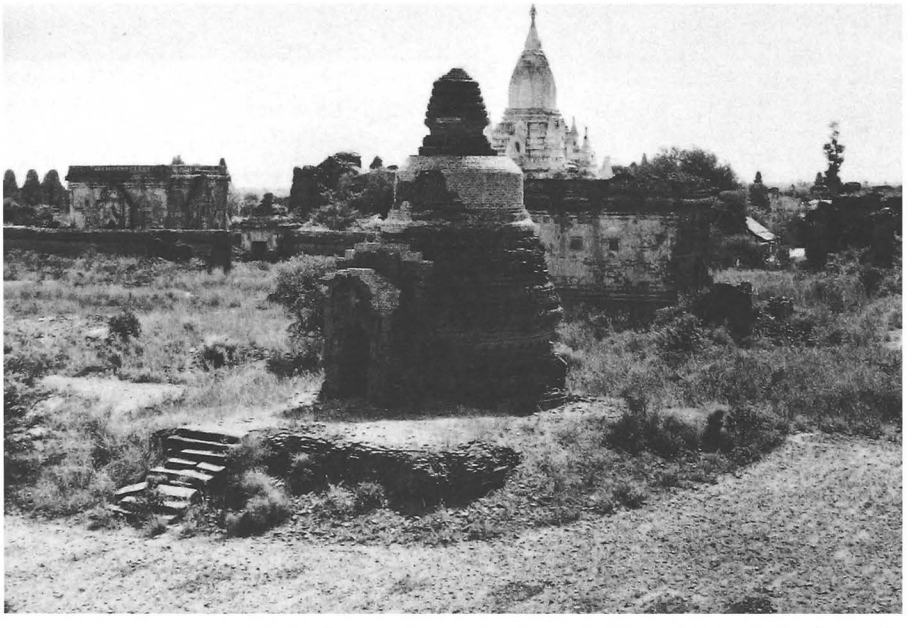
670 b - From south-west, together with 526 and 447 in the background

5 present condition
- maintained.
- upper parts repaired.

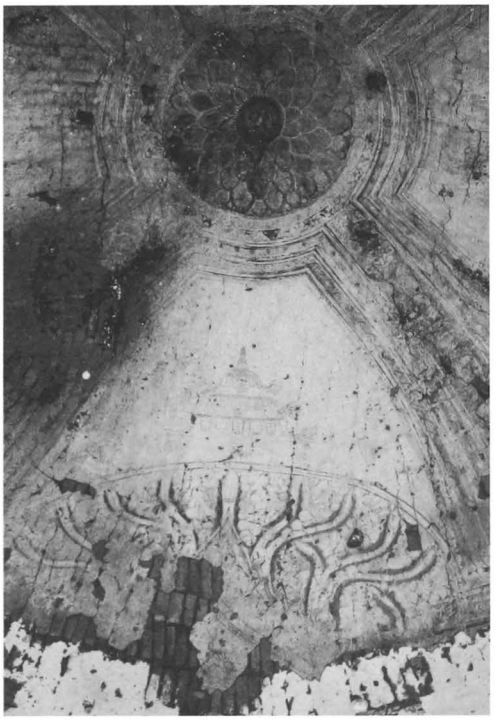
670 d - Shrine, cupola and east wall, from west

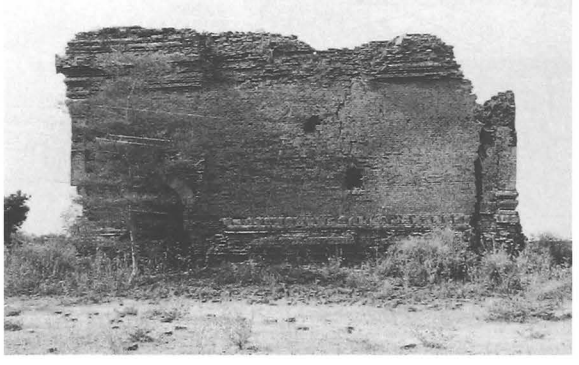
5 present condition
- half-ruined.
- vaults collapsed over west room.
- west wall leaning outwards.
- ground floor partly buried under debris.
- structure badly cracked.

671 c - East face, from south-east

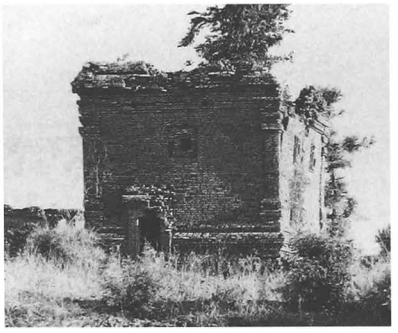
5 present condition
- half-ruined.
- vaults collapsed.
- ground floor buried under debris.

672 b - North face, from north-west

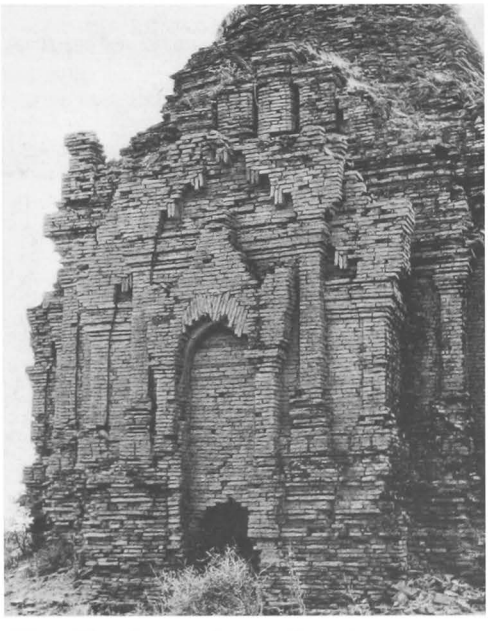
673 e - West forepart, from south-west

5 present condition
- no maintenance.
- base disintegrated.
- upper parts badly damaged and endangered.

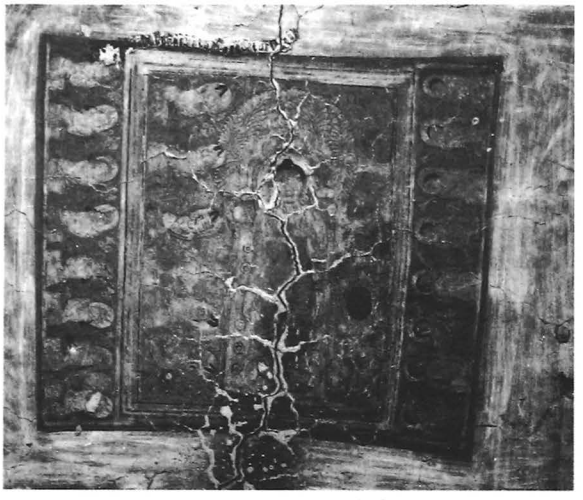
673 f - South vestibule vault, standing Buddha figure with attendants

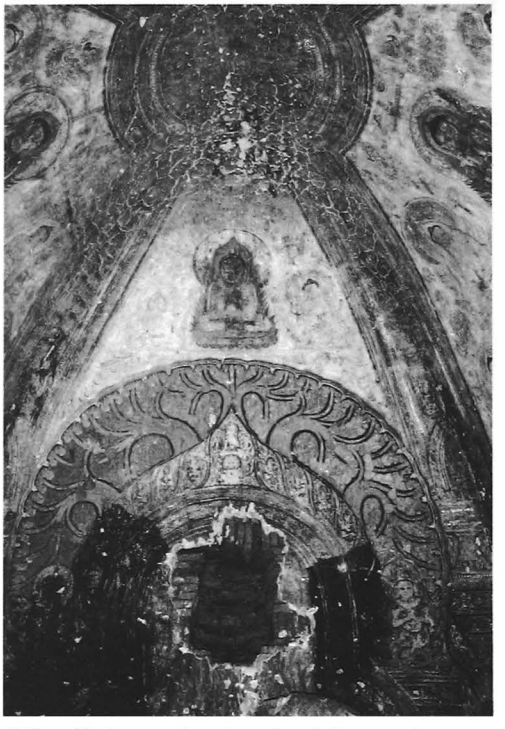
673 g - Shrine, vault and west wall, from east

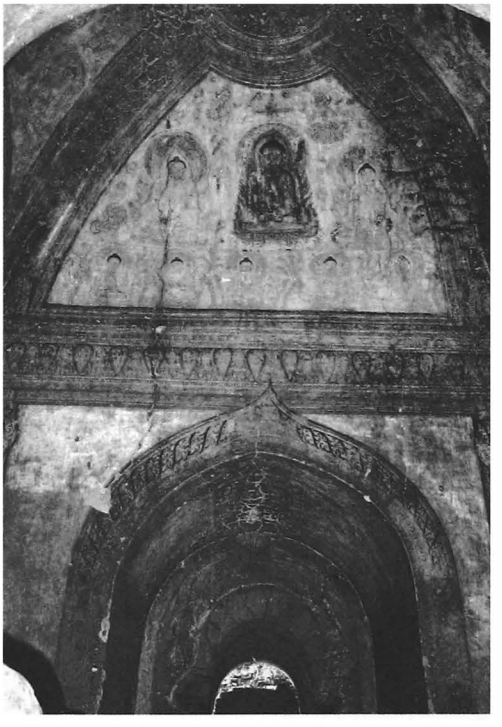
673 h - Shrine, north quadrant, north wall and vestibule

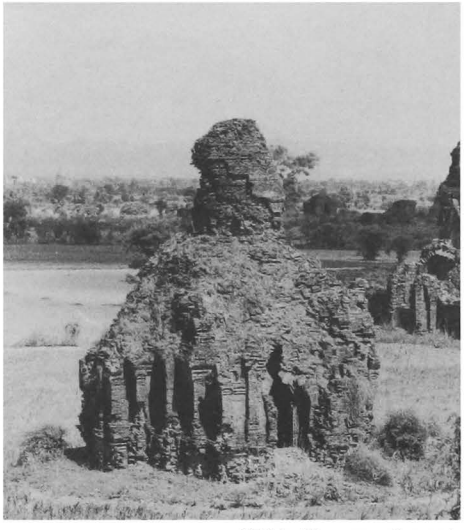
674 b -From south-east

5 present condition
- no maintenance.
- base disintegrated.
- east porch collapsed.
- upper parts badly damaged and endangered.

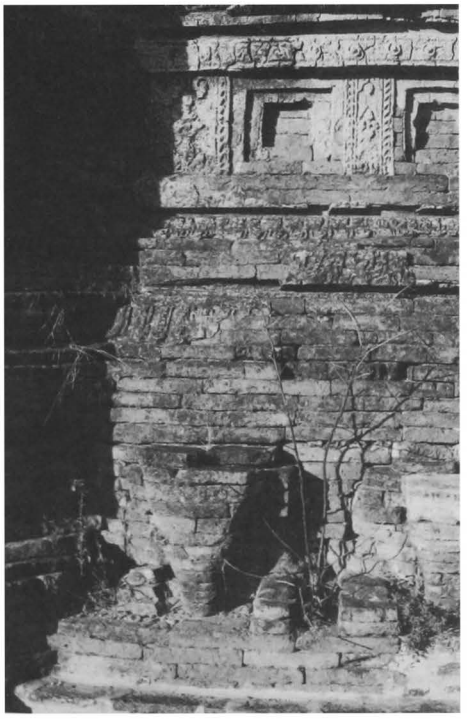
675 e - Detail of base, south side of west porch

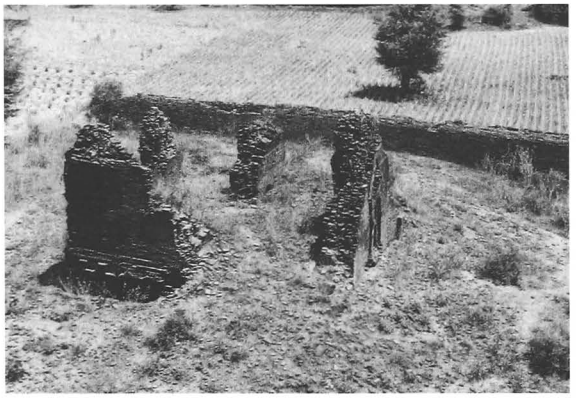
5 present condition
- ruined.
- vaults and parts of walls collapsed.
- ground floor buried under debris.

677 b - From south-east

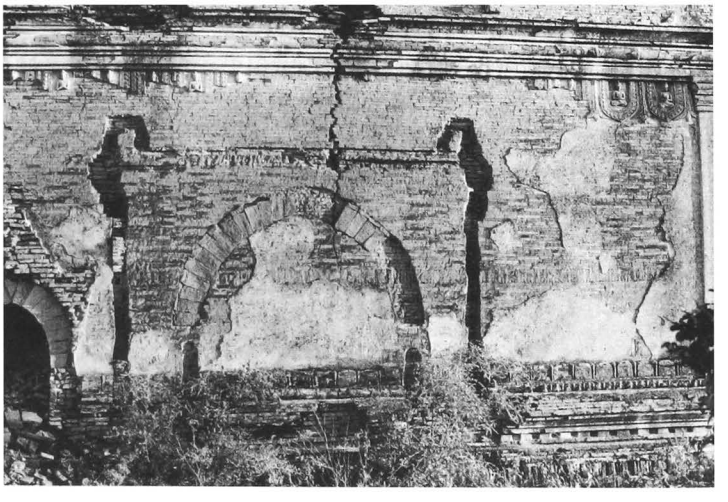
5 present condition
- half-ruined.
- east wall and vault of east corridor collapsed.
- cleared, repaired and strengthened (Const. Corp.) 1989.

682 e - North face, detail of central part

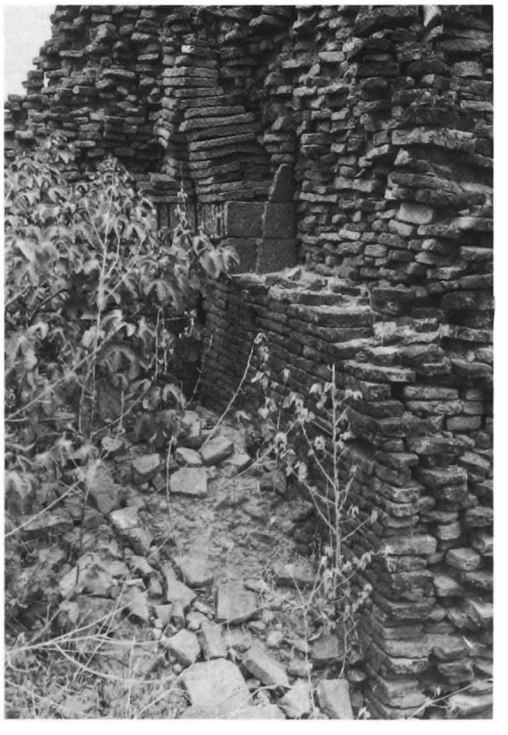
5 present condition
- ruined.
- vaults collapsed.
- ground floor buried under debris.

683 c - Shrine, north-west corner, from south-east

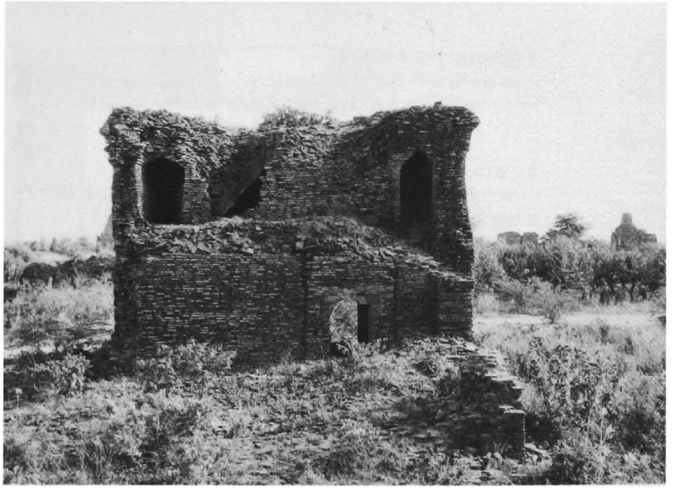
5 present condition
- repaired (Const. Corp.) 1992.

690 b - East face, from south-east

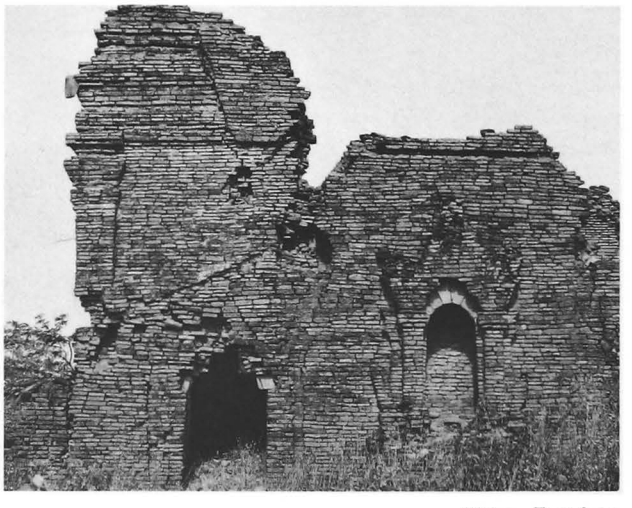
5 present condition
- ruined.
- vaults and roof collapsed.
- ground floor buried under debris.

691 b - From south-east

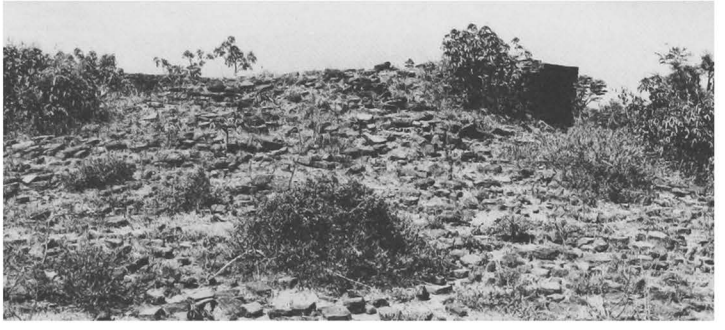
5 present condition
- ruined.
- ground floor buried under debris.

694 b - From north-east

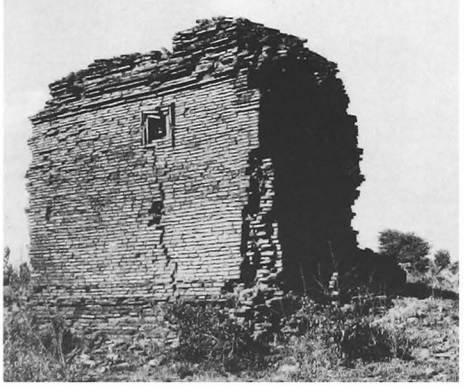
5 present condition
- ruined.
- vaults and roof collapsed.
- ground floor buried under debris.
- cleared and repaired (Const. Corp.) 1992.

695 b - West face, from north-west, 1985

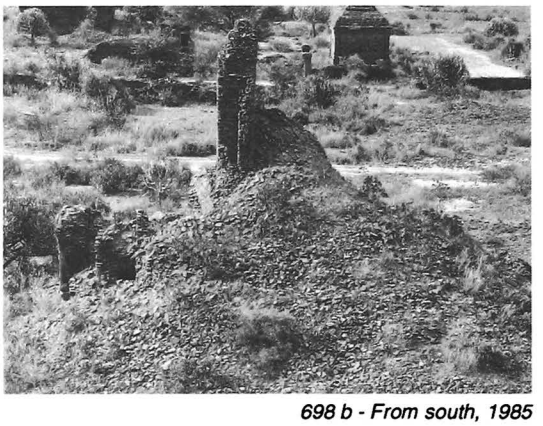
698 b - From south, 1985

5 present condition
- previously half-ruined, upper storey destroyed by the 1975 earthquake.
- vaults of corridor collapsed.
- cleared and repaired (Const. Corp.) 1991-92.

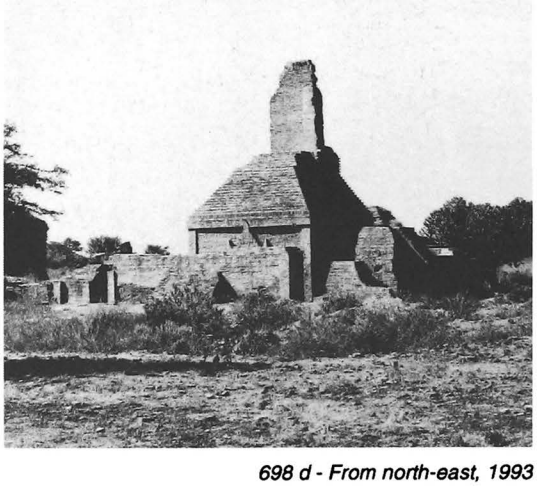
698 d - From north-east, 1993

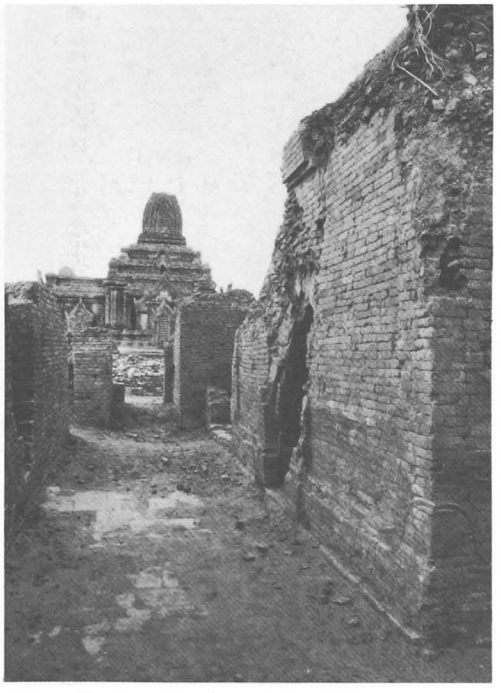
698 e - East corridor, from north, 1991, together with 697 in the background

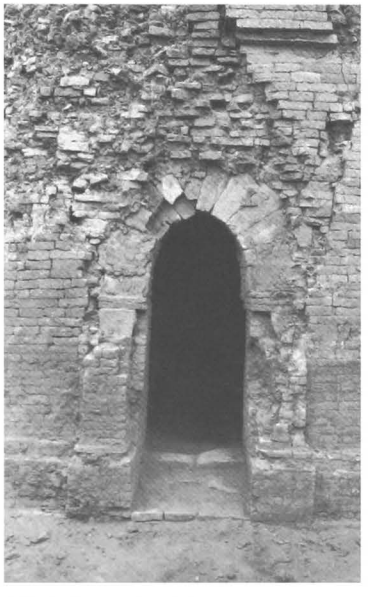
698 f - Central cell door, from east, 1991

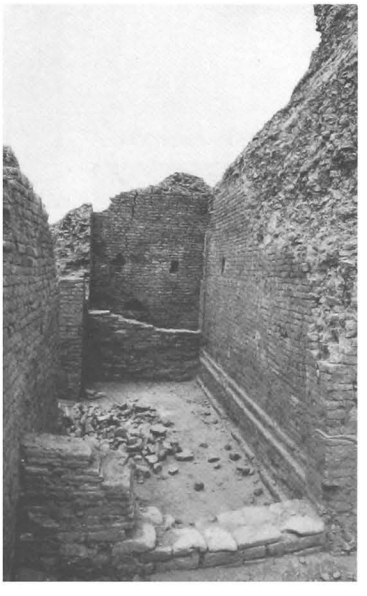
698 g - South corridor, from east, 1991

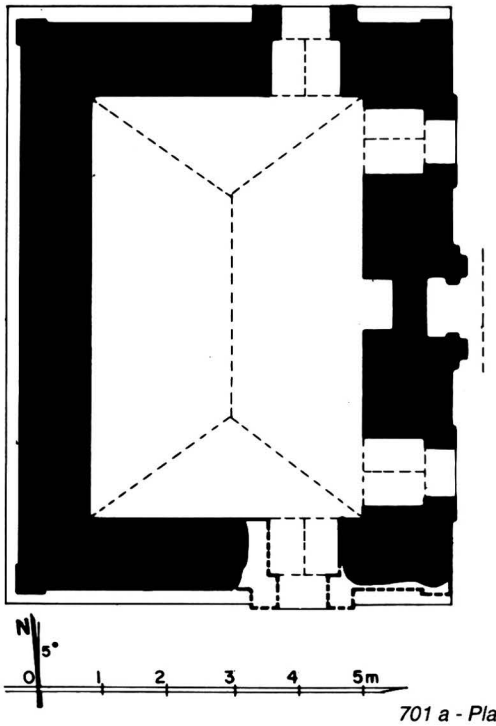
701 a - Plan

5 present condition
- ruined.
- vaults collapsed.
- cleared and repaired (Const. Corp.) 1991.

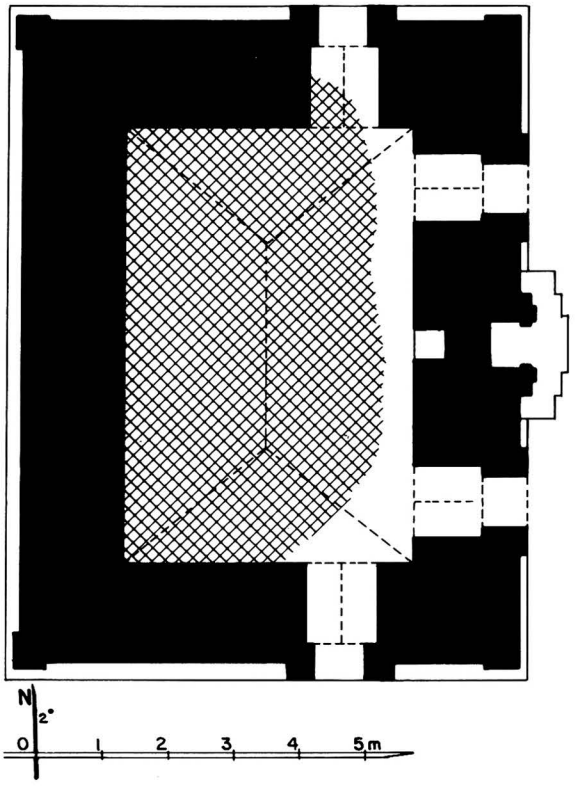
703 a - Plan

5 present condition
- half-ruined.
- vaults collapsed.
- ground floor buried under debris.

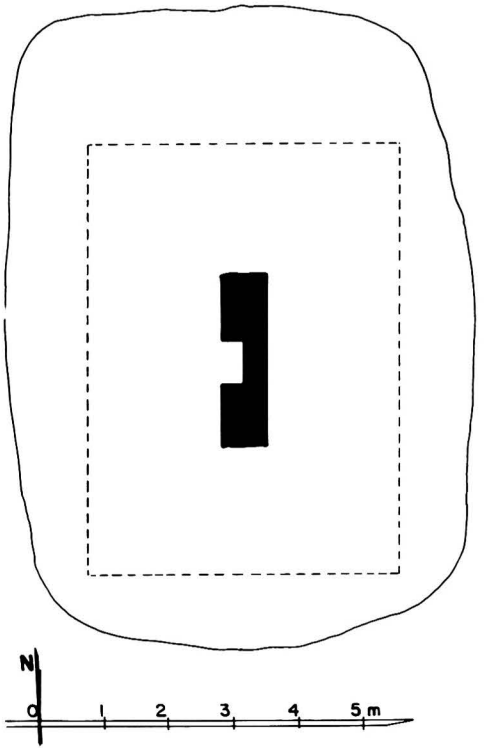
704 a - Plan

5 present condition
- ruined.
- only parts of walls remain.
- ground floor buried under debris.

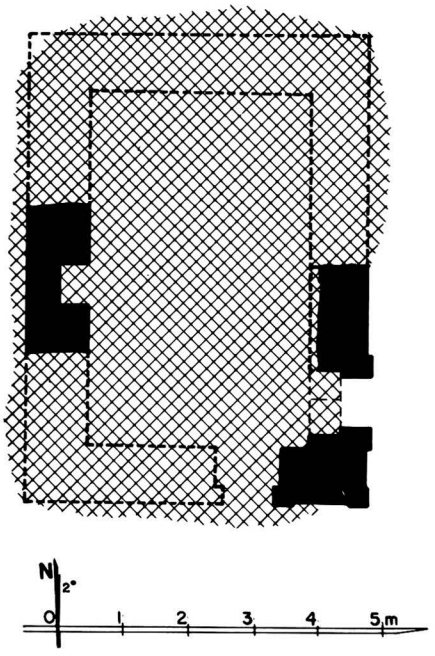
705 a - Plan

5 present condition
- ruined.
- vaults and roof collapsed, only parts of walls remain.
- ground floor buried under debris.

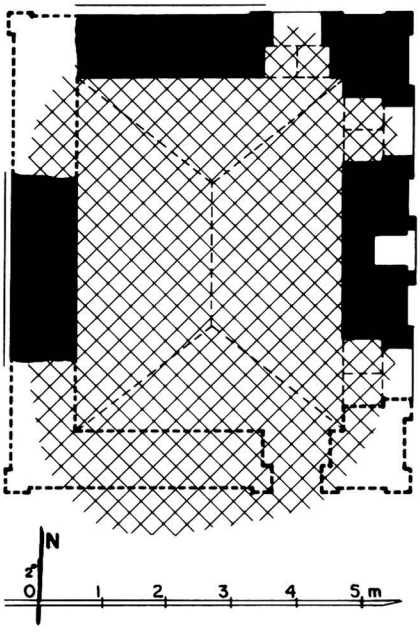
706 a - Plan

5 present condition
- ruined.
- vaults collapsed.
- ground floor buried under debris.

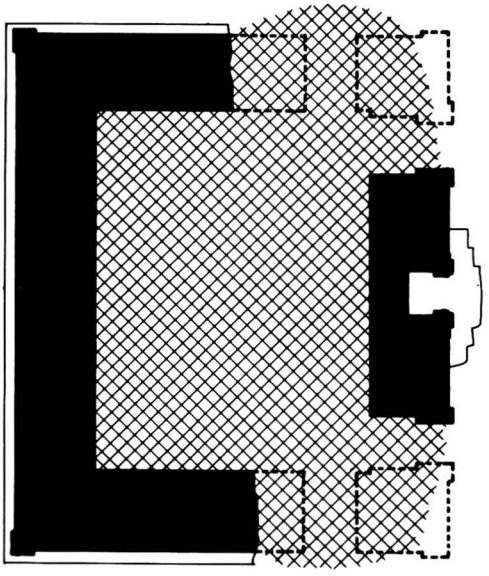
707 a - Plan

5 present condition
- ruined.
- vaults collapsed.
- ground floor buried under debris.

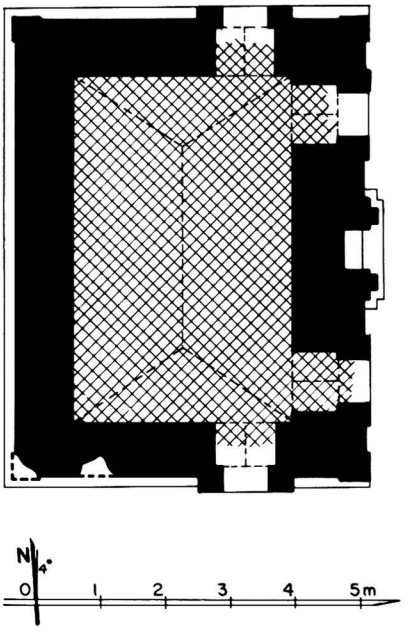
708 a - Plan

5 present condition
- ruined.
- vaults collapsed.
- ground floor buried under debris.

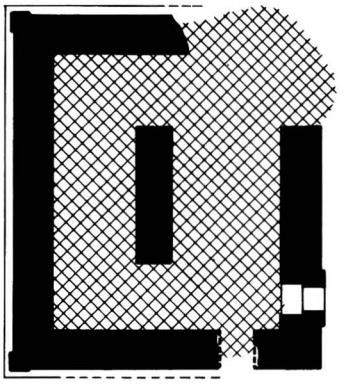
710 a - Plan

5 present condition
- ruined.
- vaults and roof collapsed.
- ground floor buried under debris.

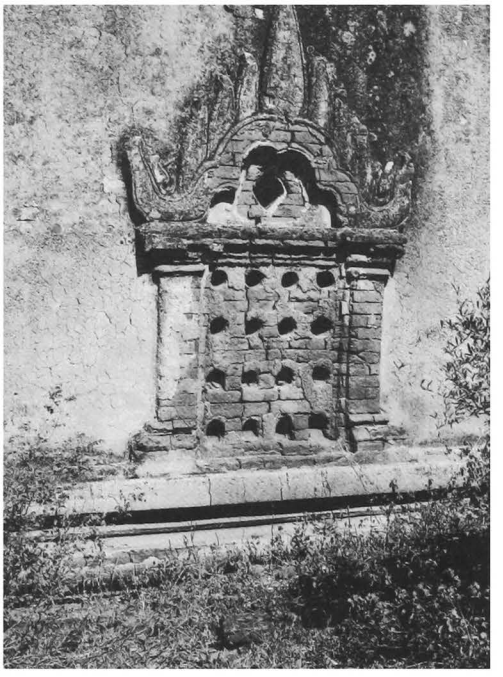
716 e - East face, window on north side

5 present condition
- half-ruined.
- vaults and upper parts collapsed.
- structure badly cracked.
- ground floor partly buried under debris.

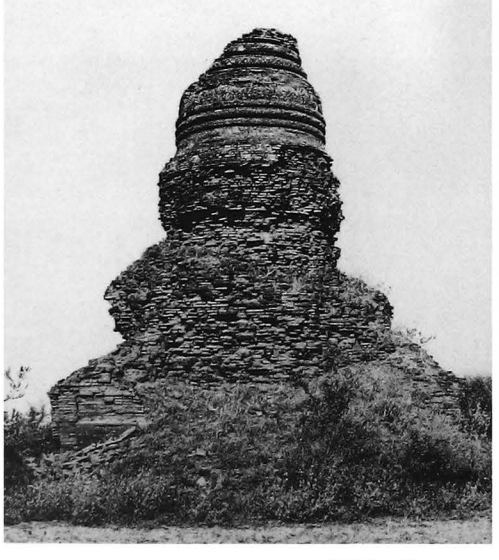
721 b - From east

5 present condition
- half-ruined and endangered.
- base and terraces disintegrated.

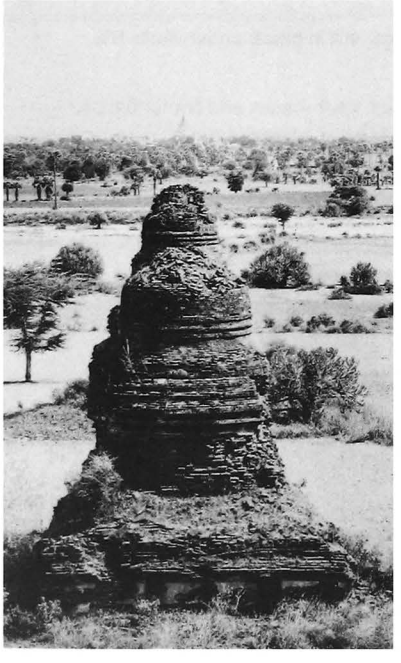
723 b - From south, in line with 721 and 1 Shwe-zigon

5 present condition
- half-ruined and endangered.
- base and terraces disintegrated.

remarks
- seen from temple **712 Thin-kan-yon**, the twin stupas **721** and **723** are precisely located on a nearly north-south line aiming at **1 Shwe-zigon**; whether this is intentional cannot be proved.
- for other instances of two similar stupas aligned north-south, see **19-18**, **405-406** or **1326-1325**.

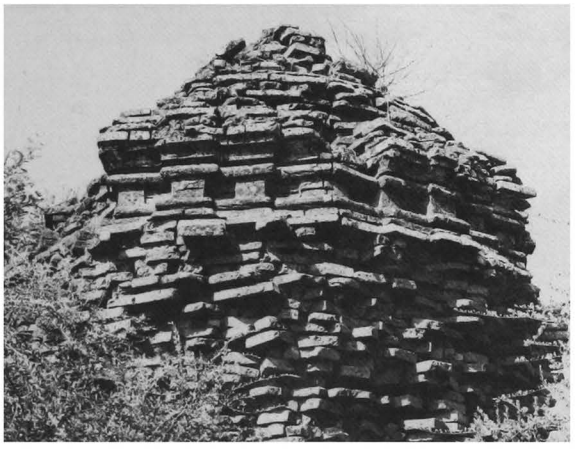
726 b - Top part, from north-east

5 present condition
- no maintenance.
- base and terraces disintegrated.
- upper parts destroyed.

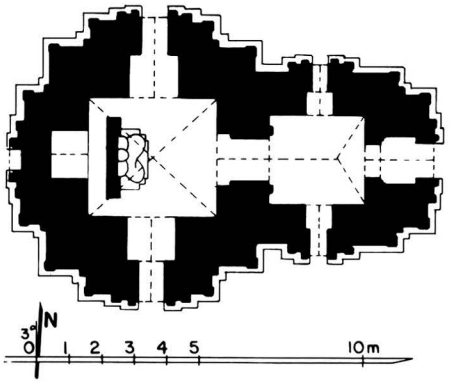
732 a - Plan

5 present condition
- no maintenance.
- base disintegrating.
